DEVELOPMENT AND IMPROVEMENT OF Q3s

– A Three Year Old Child Side Impact Dummy

Paper Number 09-0358

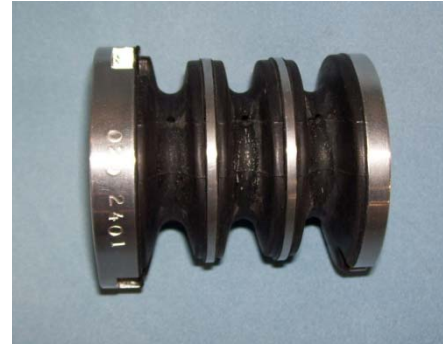
Figure 1, molded neck

locations (frontal, lateral and rear) in order to govern the performance of the neck. Cuts were introduced into the front of the neck to soften it, and comply with the extension performance requirement. The molded neck is shown in Figure 1. Different rubbers were experimented with to optimize the neck performance. The test data is summarized later in this paper.

A new neck was designed to meet the flexion, extension, lateral bending and torsion biofidelity requirements. Since each test has its own performance specification, it requires a complex structure to meet these requirements simultaneously. The neck design consists of four aluminum vertebra discs and rubber segments between the aluminum discs. The rubber segments have an oval-like shape with circumferential V-shaped grooves. The V shape opening angle varies around the neck in different

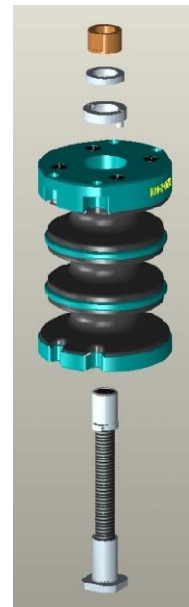
Figure 2, Neck assembly with cable

A torsion cable was designed into the neck assembly to govern the torsion performance. The cable has metal sheaths crimped to both ends. At one end, the metal sheath has a key to engage with a ring underneath to control the torsion performance of the neck. During the

development of the previous torsion cable, it was found that the asymmetrical torsion cable caused asymmetrical performance, which requires offset of the key position to compensate and induce earlier rotation in order to gain symmetrical neck performance. It was found a symmetrical torsion cable was desired and identified in the design to eliminate the offset of the key feature. The cable and the rings are shown in Figure 2.

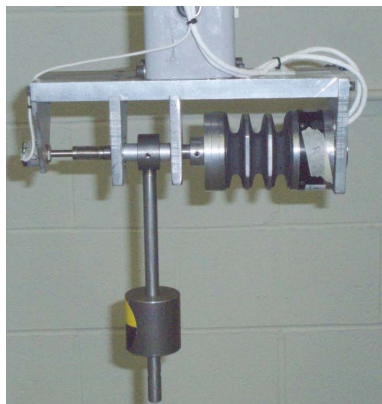
Figure 4, Headform for torsion pendulum test

The torsion was tested with a special headform designed by VRTC, shown in Figure 4. This headform has a neck load cell to measure the moment M_z of the neck and a rotary pot to measure its rotation about Z axis.

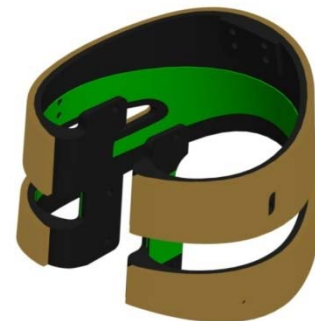
Figure 12, Q3s rib cage design with metal insert

After the finite element analysis, prototype parts were fabricated accordingly for testing to validate the concept. The shape of the metal insert was optimized in design to address some manufacturing challenges. The final design of the rib cage with the insert is as shown in Figure 12.

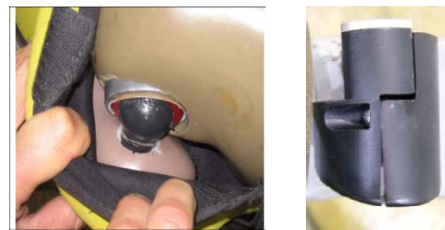
Figure 16 Hip ball pop out from its cup

It was observed in some severe test condition, the hip ball popped out of the ball retainer, also referred as the cup.

From the investigation, the cause of this problem was due to the plastic cup, not being strong enough to retain the hip joint in position. Under severe test condition, the hip cup will deform and allow the hip ball to slip out of the cup retainer. To address this problem, the deformation of the hip cup needs to be limited while the engagement between the ball and the cup needs to be improved.

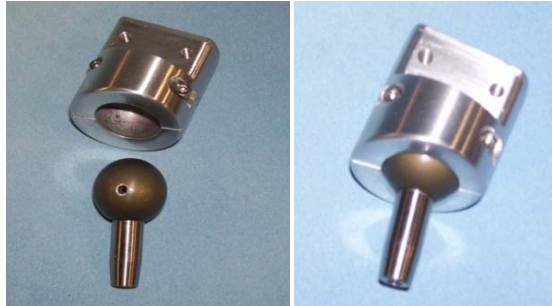
Figure 17, New hip joint design

To reengineer the joint, aluminum material was used to replace the plastic material for the cup, which increases the rigidity of the hip cup significantly. At the same time, the plastic hip

ball and ball shaft was replaced with a hardened aluminum ball. The ball diameter was reduced from 30 mm to 25.4 mm, while the shaft diameter was reduced according to maintain the hip joint range of motion. This design change increases the engagement area between the ball and the cup and therefore strengthens the ball joint.
